DOLE RESERVOIR DAM & DIKE

NH 00143 & NH 00483

PHASE I INSPECTION REPORT NATIONAL DAM INSPECTION PROGRAM

MARCH 1980

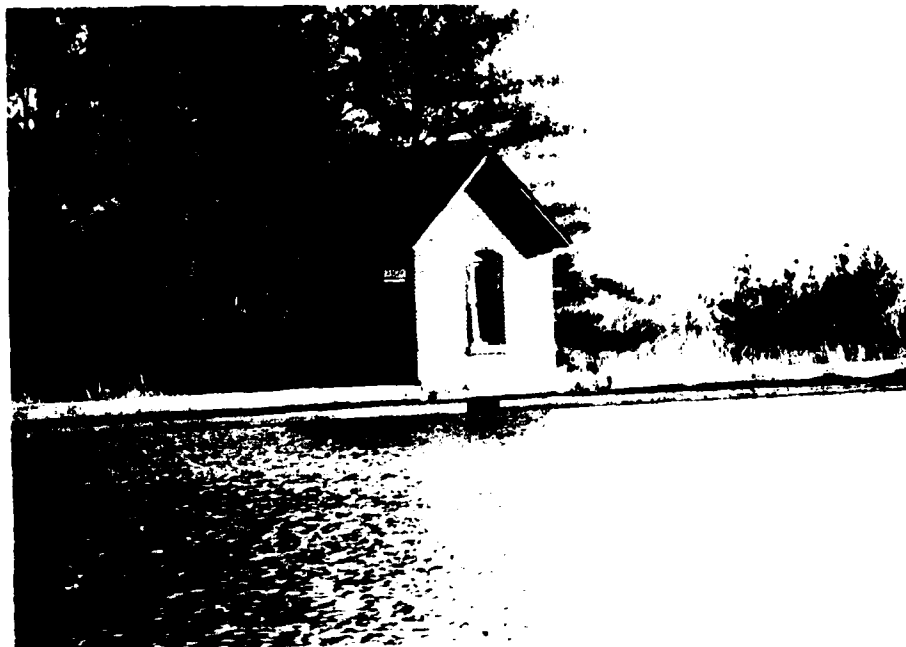
The crest of the dam is mostly covered with unmowed grass and coarse weeds (see Photo Nos. 2 and 3). The upstream edge of the crest is retained by a vertical concrete wall which is 12 inches wide at the top. The cap of this wall is spalling at several locations, and there is a 3-foot long and 1/8-inch wide horizontal crack exposing reinforcing steel on the front face of the wall by the gate house (see Photo Nos. 5, 6, and 7). Near the abutments, the embankment crest is at about the same elevation as the top of this wall, but in the deeper part of the valley, the crest of the embankment is generally 6-12 inches lower than the top of the concrete wall (see Photo No. 7). It is not possible to determine from the visual inspection the elevation of the bottom of this wall. The left abutment appears to be bedrock, and the right abutment appears to be soil (see Photo No. 4).

Photo No. 5 - Spalling of concrete cap at
left abutment of dam.

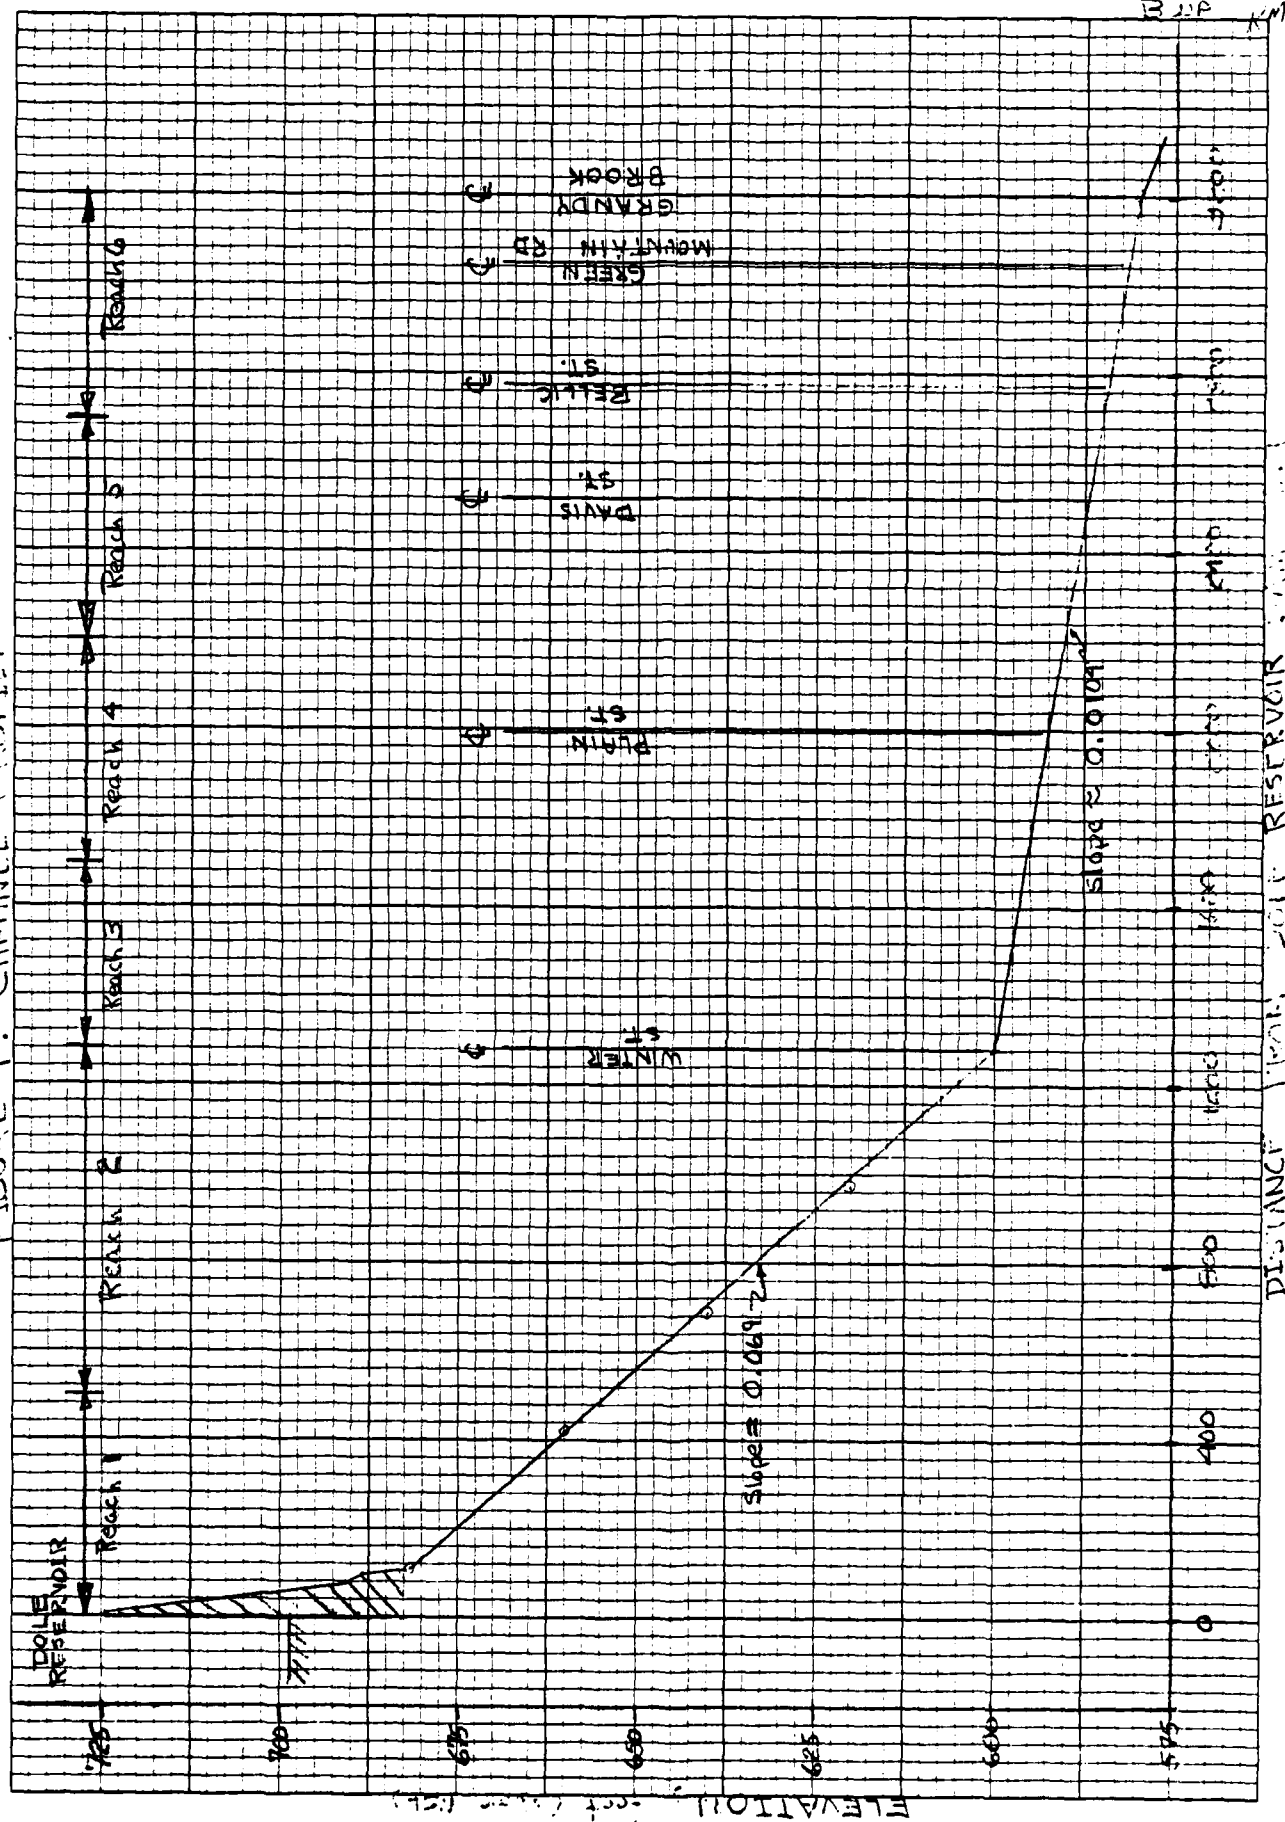
FIGURE 4: CHANNEL PROFILES

a. Pertinent Data (see Figure 4 for Channel Profile)
